IR Thermography of International Space Station Radiator Panels

ASNT Fall 2010 Conference

Damage to Radiator Panel Detected September 2008

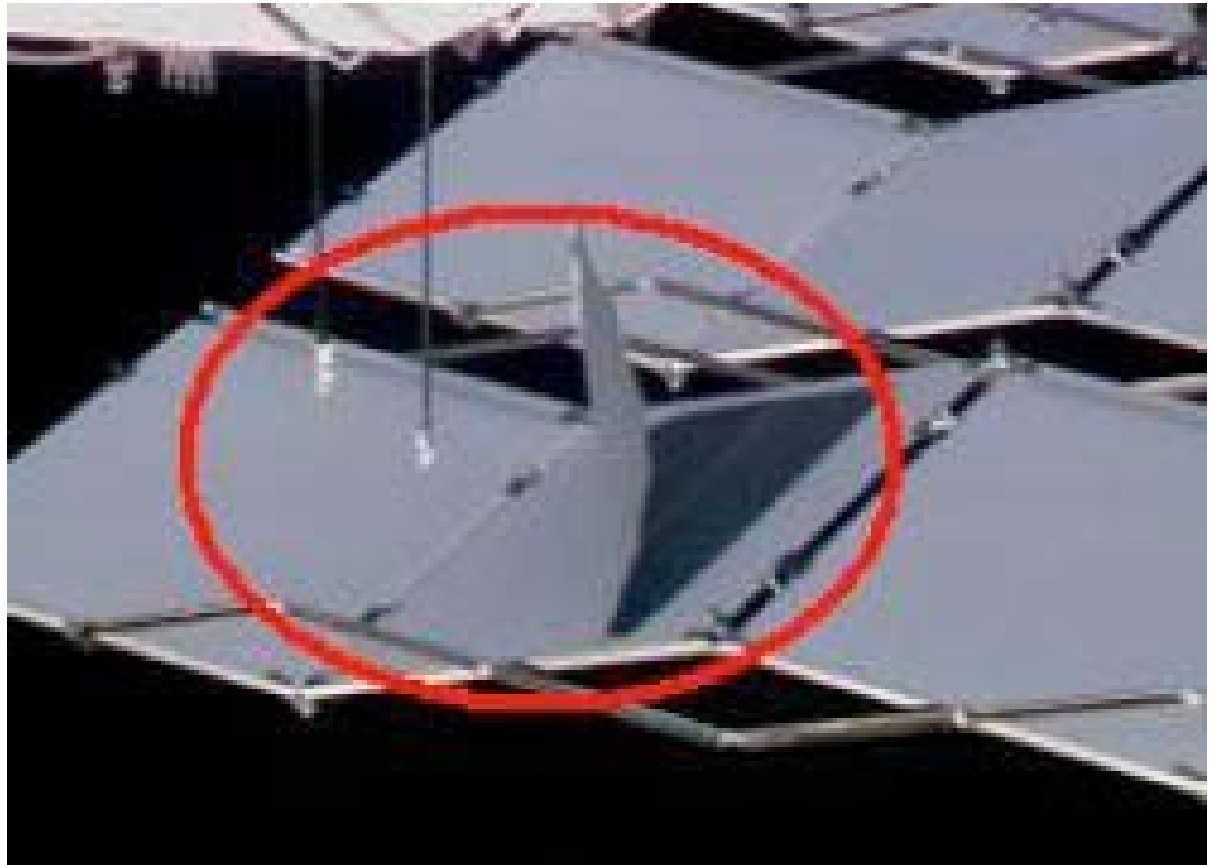
Peeled facesheet

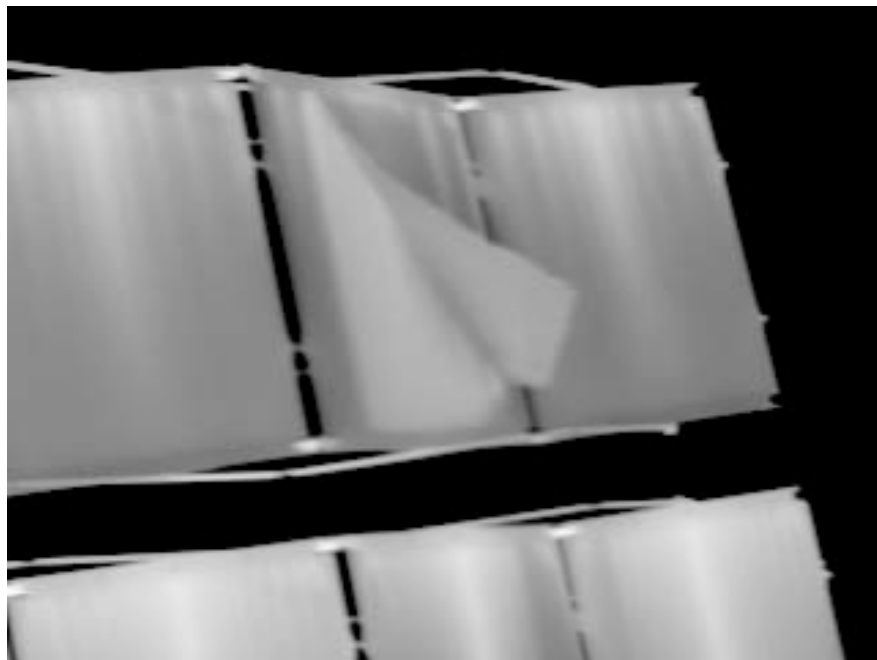
Peeled side

Light areas are warmer
Black areas - space

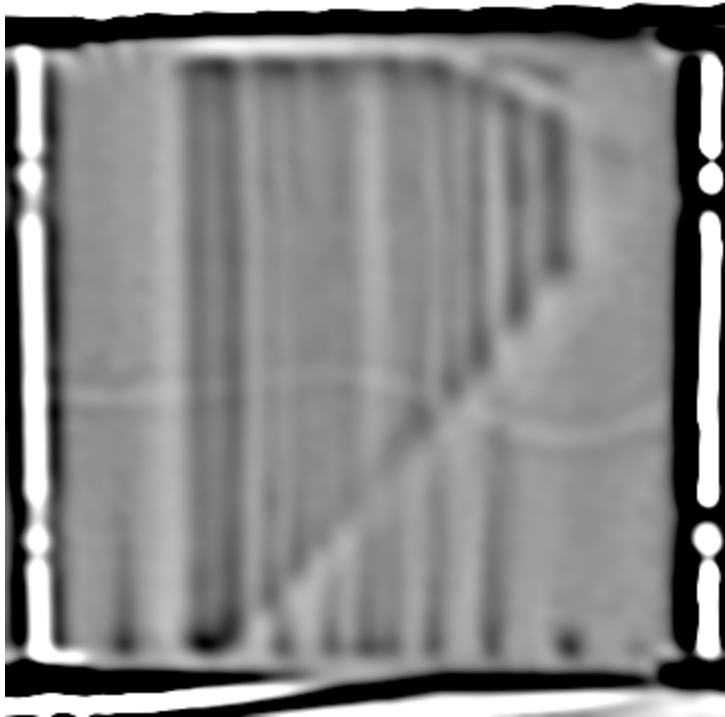
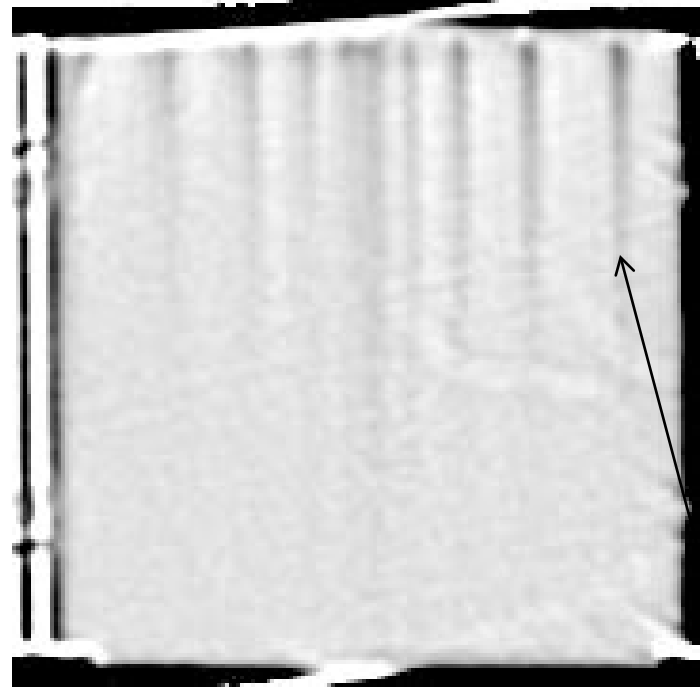
Comparison of Laplace of Infrared Images of Damage and Undamaged Panels

Damaged

Undamaged

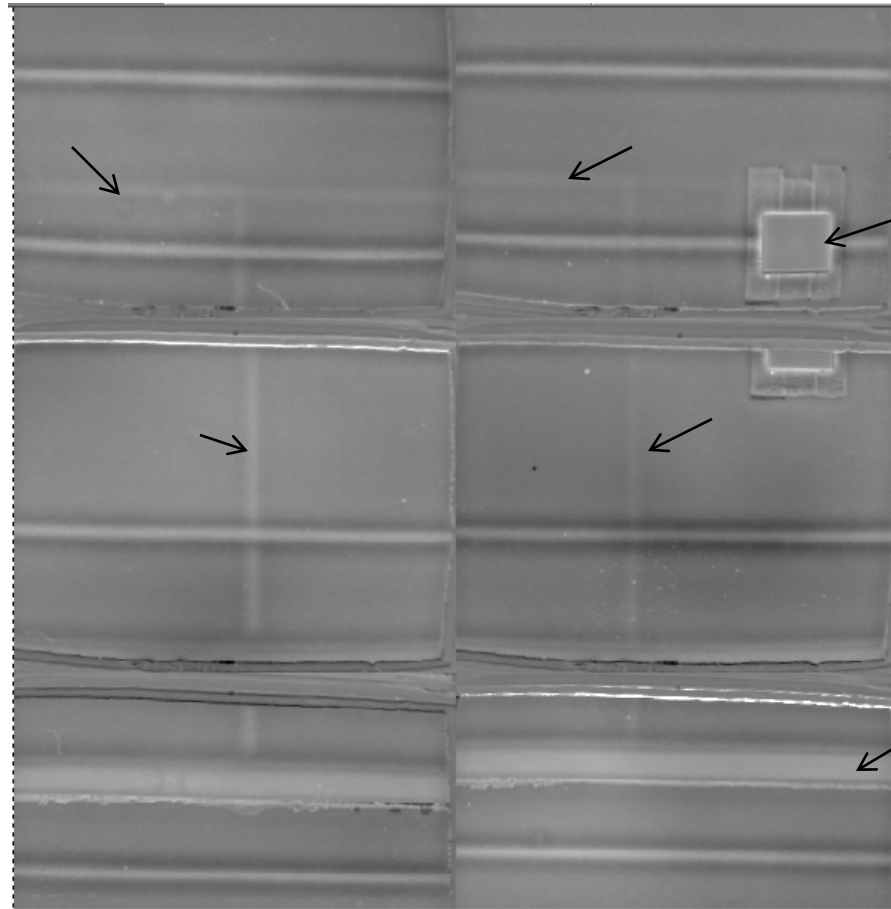
Frame 26 2D

Strain gage on
the surface

Facesheet overlap

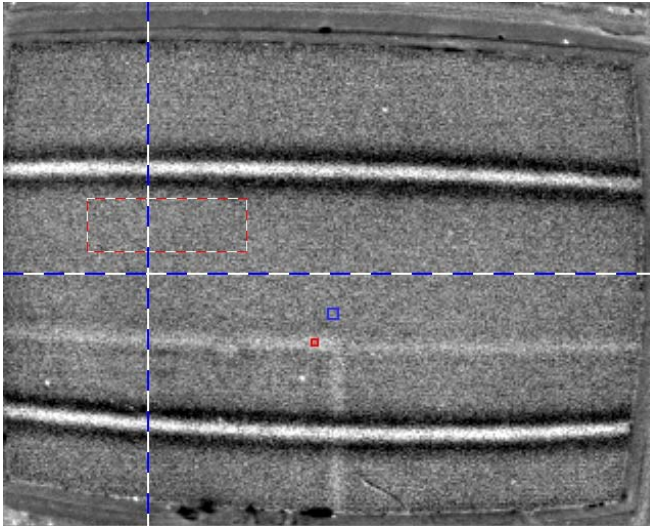
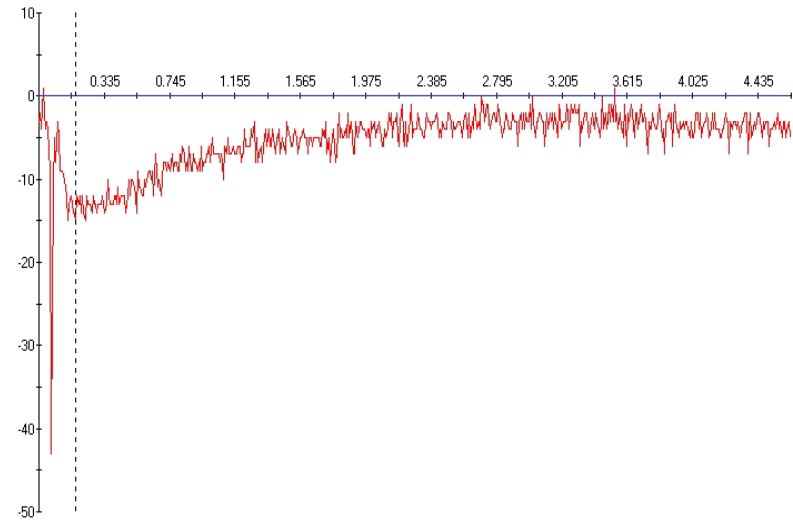
Adhesive Sheet Overlap

Comment: Provides negative contrast (cold area) due to additional adhesive

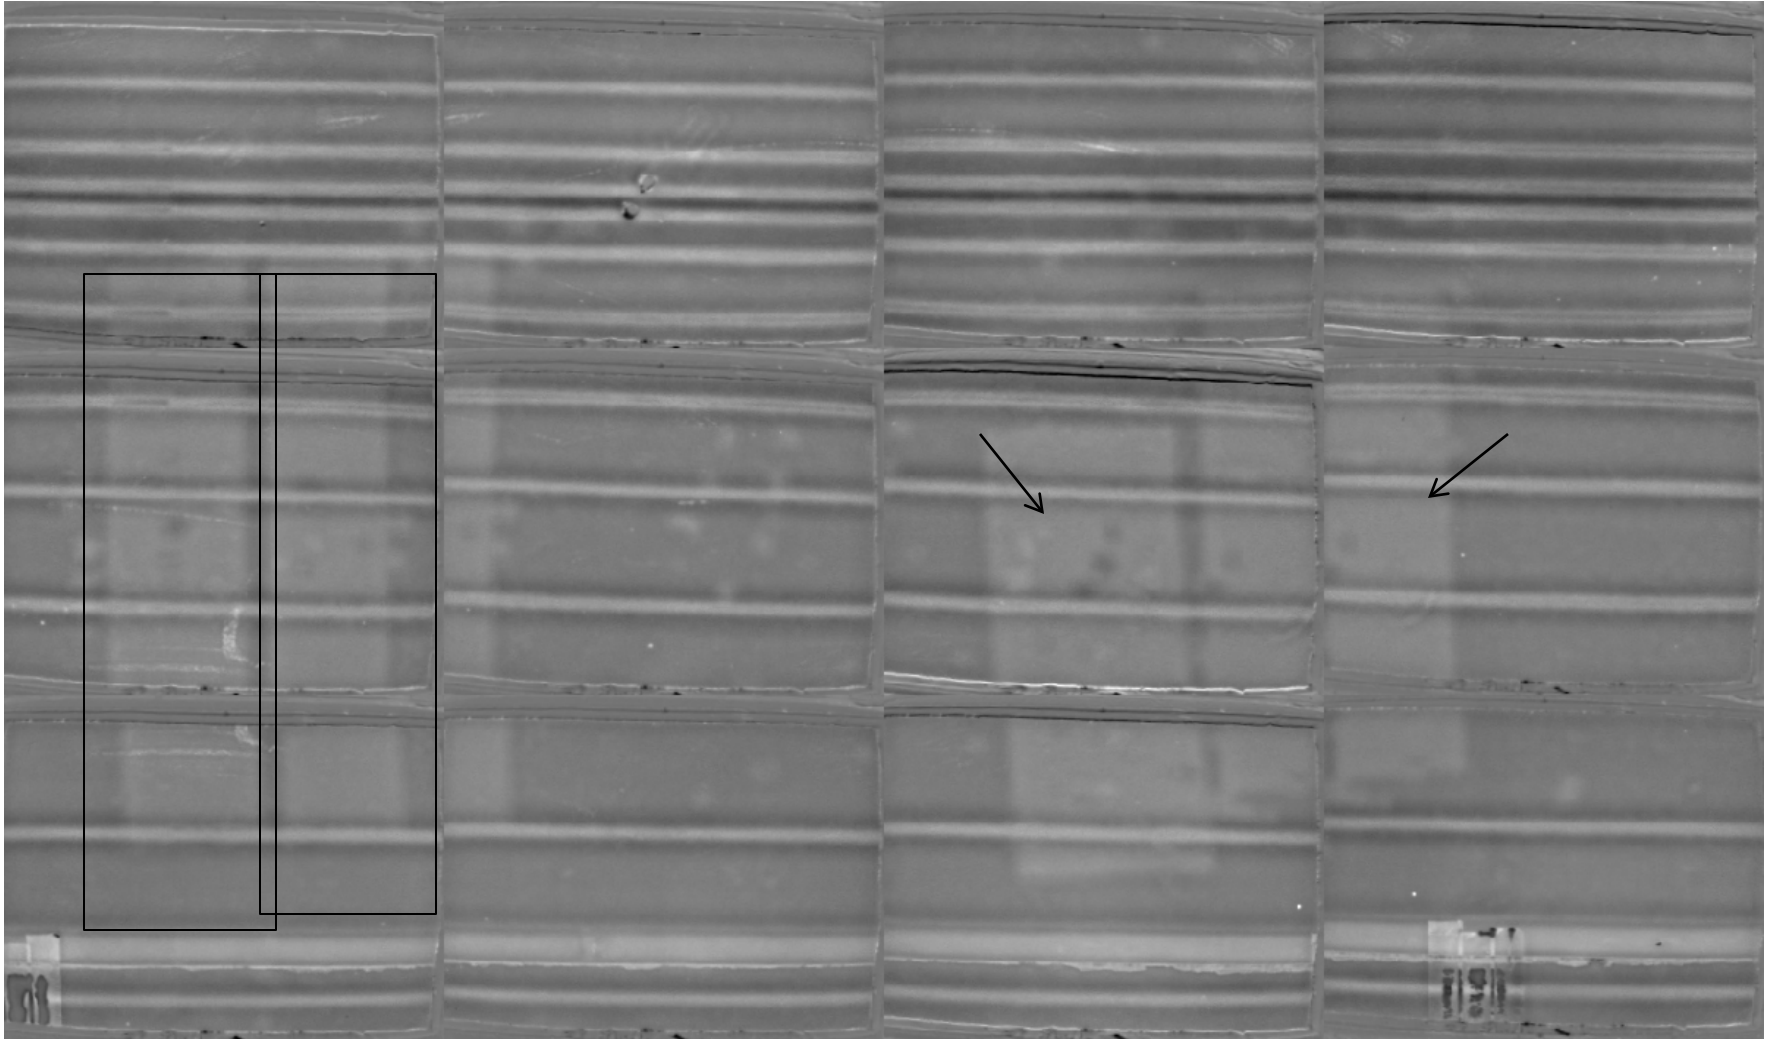
Frame 45 2D

- Show Up Early
- Only Appear on Panel 2B
- Tube signatures evolve through these indications so they aren't very thick
- Most likely 'patches' in film adhesive

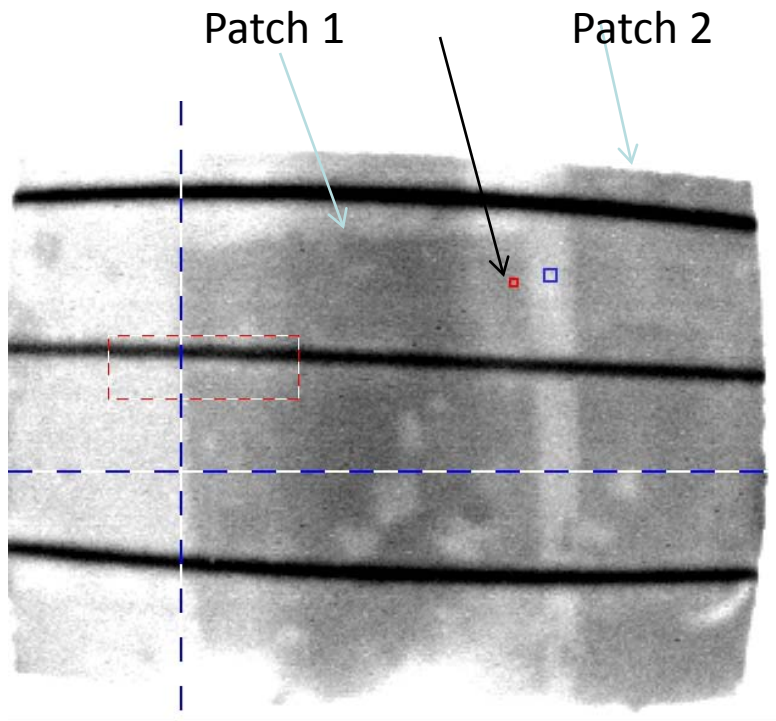
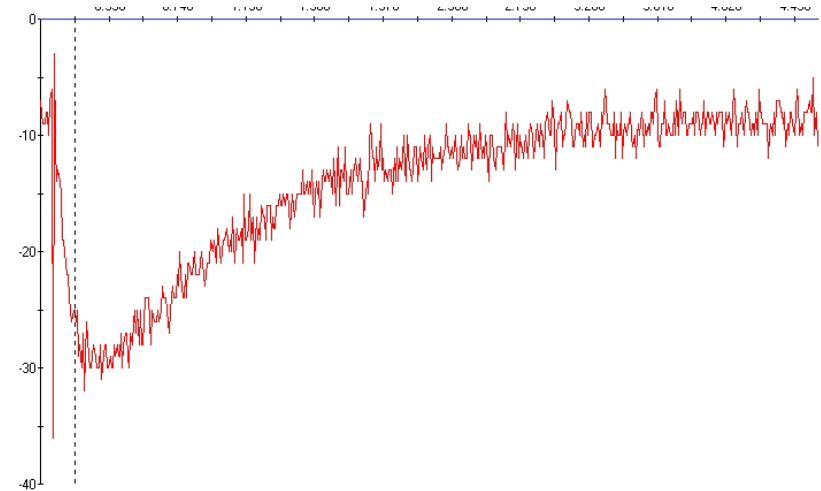
Additional Adhesive Patch

Red dot on the patch
Blue outside the patch

Comment: Provides a negative contrast (cold area) due to additional adhesive layer or layer of other material

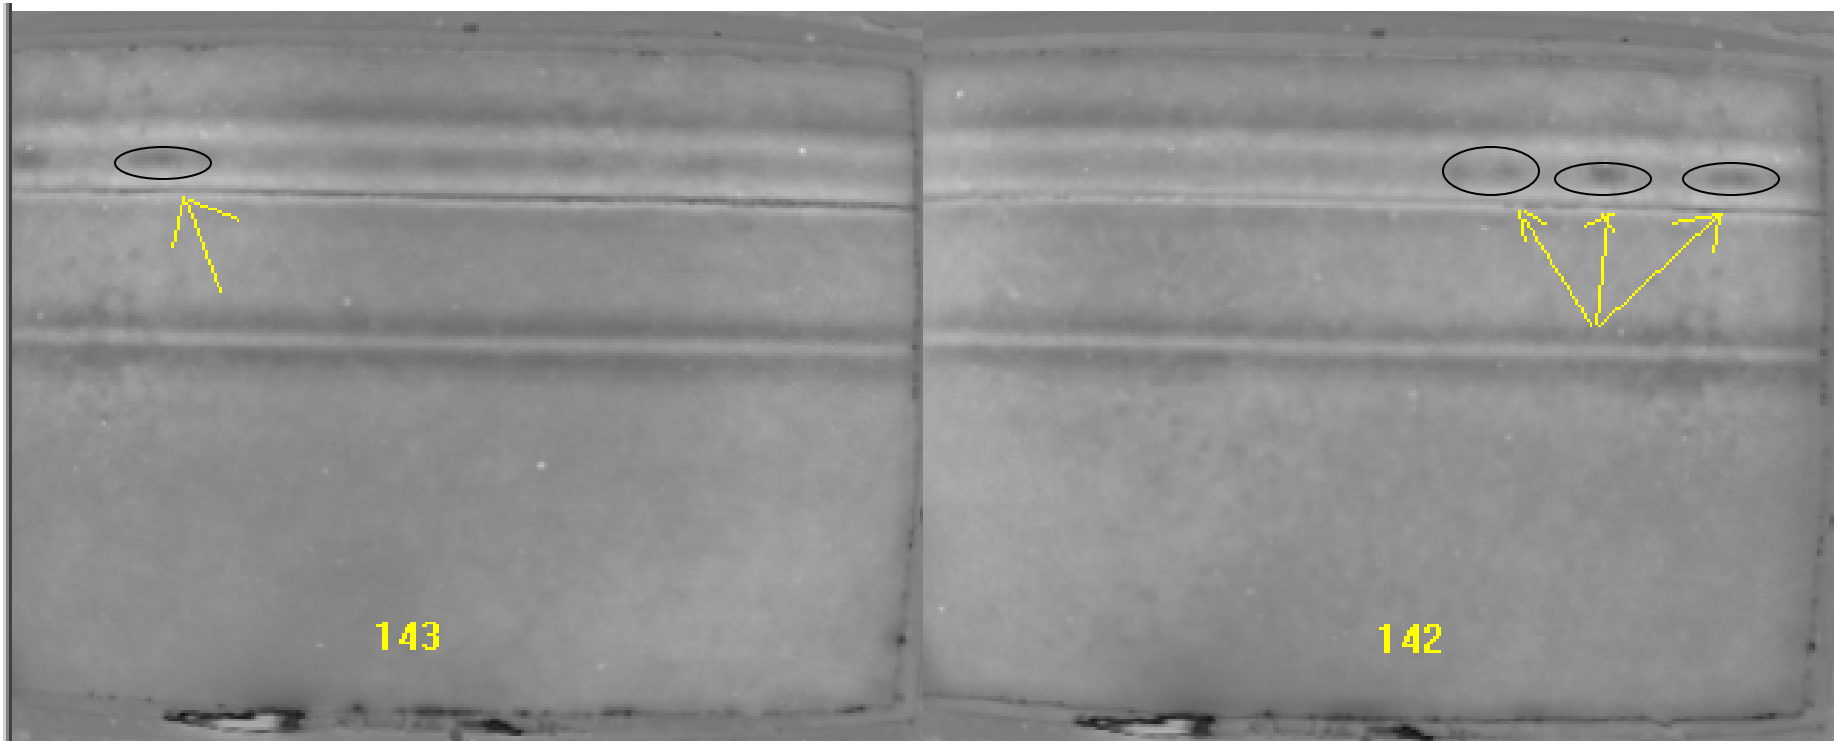
Face Sheet Debonds Panel 4a Frame 15 2D

- Show up Early
- Show up hot/bright in Raw image indicating poor thermal contact
- Evident boundary lines and timing indicate that they occur in between face sheets where facesheets overlap

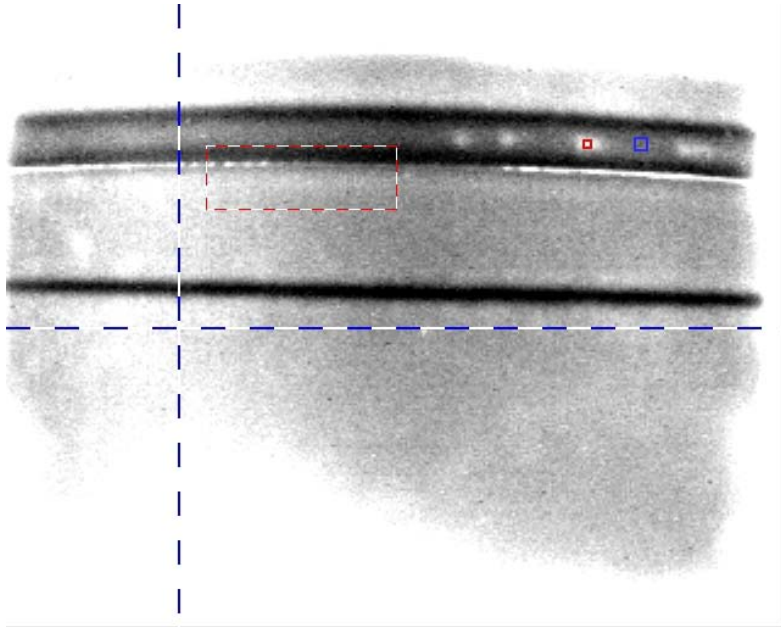
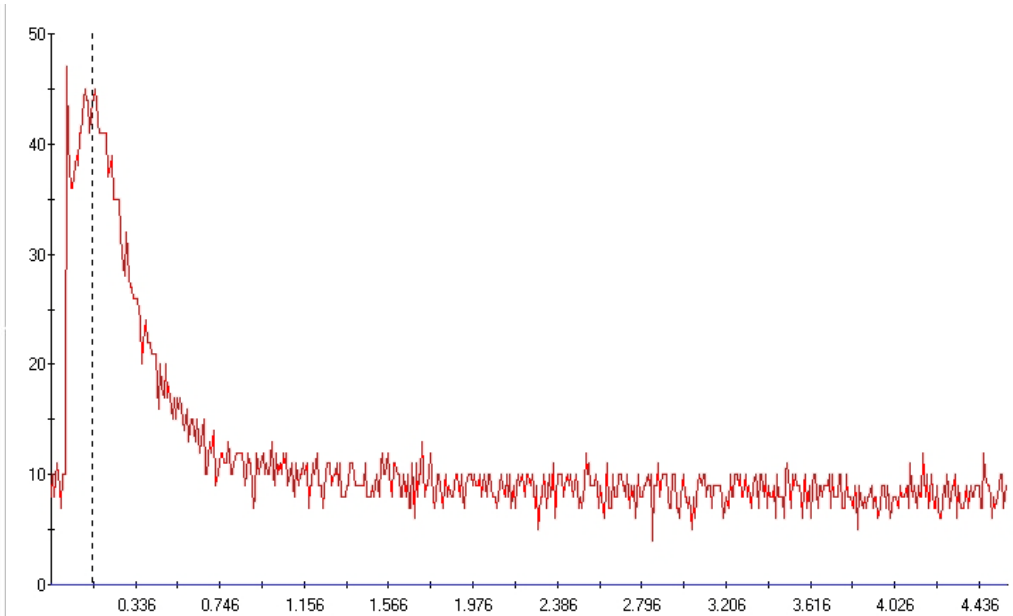
Suspect Void/Unbond at Facesheet Overlap

Comment: Warm spot indicating a void/unbond

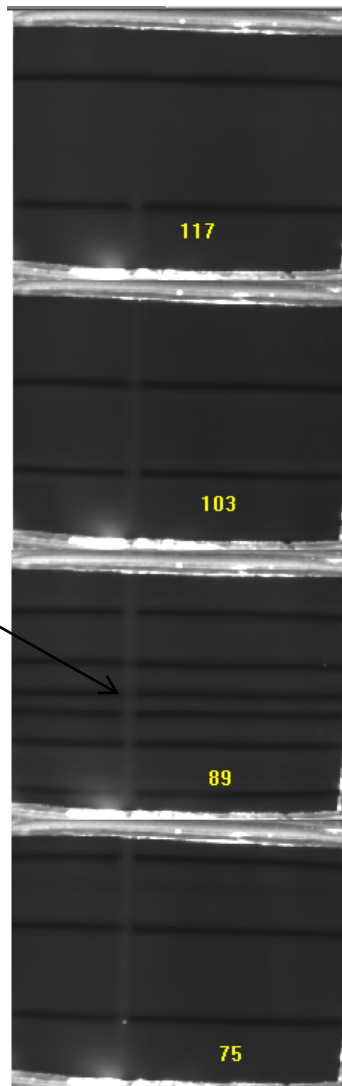
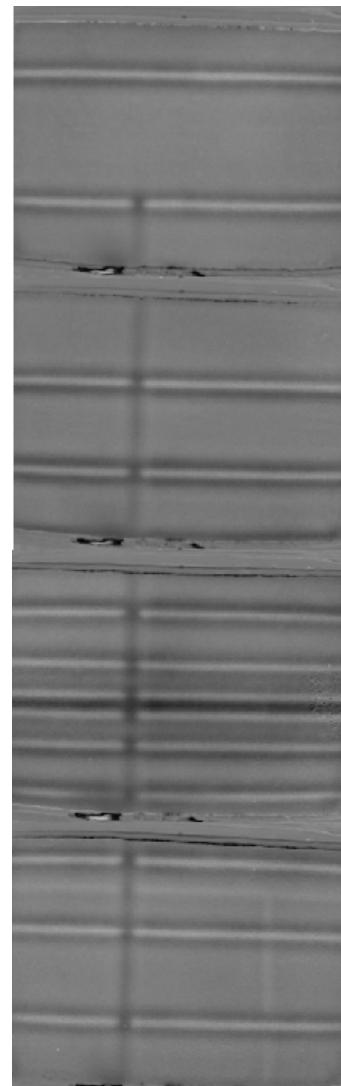
Linear Indication – Lack of Adhesive Frame 30 Raw and 2D

Linear indication

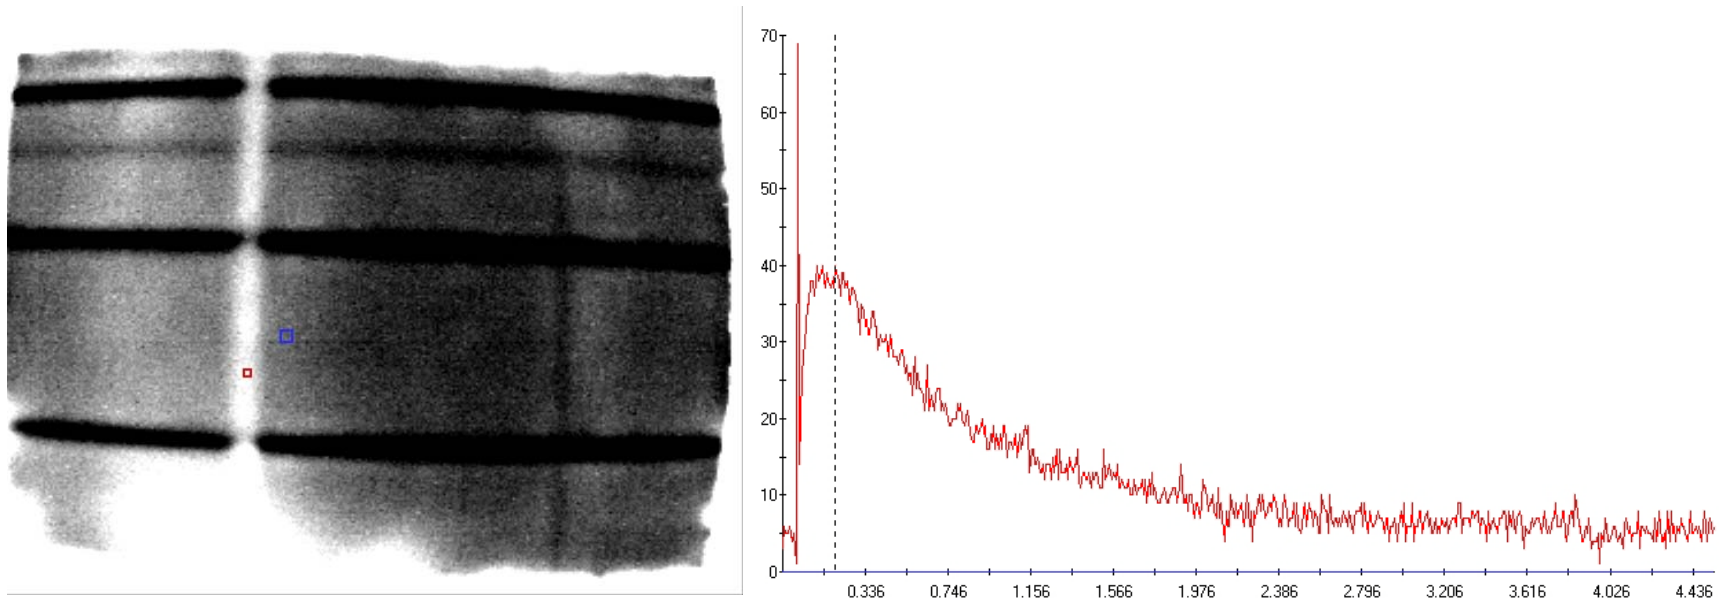
Lack of Adhesive or Debond

Comment: Provides positive contrast (Hotspot) due to lack of adhesive or gap
